Fire Risks and Occupational Safety in Historical Structures a Study on Challenges and Solutions

ABSTRACT

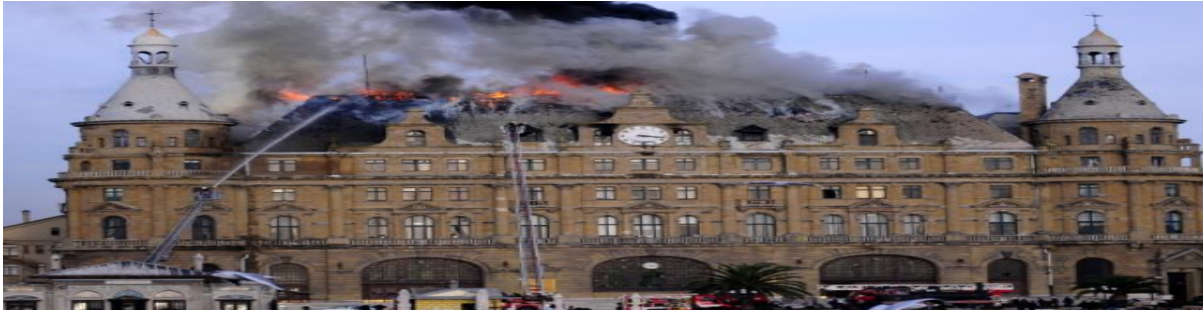
Figure 1. Haydarpaşa Train Station Fire (Özgünler, 2018)

The Haydarpaşa Train Station, an iconic structure in Istanbul, was built by two German architects between 1906 and 1908 (Atılğan, 2013). In 2010, during a restoration project, a fire broke out on the roof. The flames, fueled by strong winds, spread rapidly and caused significant damage to much of the structure. Subsequent restoration efforts aimed to preserve the station's original architecture, but some damaged sections could not be fully restored. This incident highlighted the importance of fire safety during the restoration and maintenance of historical structures (Kösebay Erkan, 2013),(Figure 1).

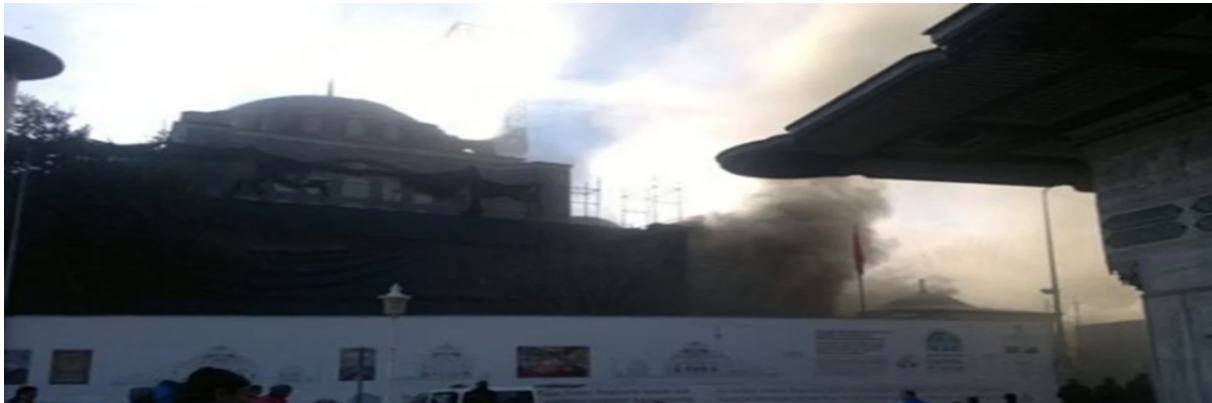
Figure 2. Kılıç Ali Paşa Mosque Fire (URL 2)

Built between 1580 and 1587 under the commission of Admiral Kılıç Ali and designed by the famous Ottoman architect Mimar Sinan, the Kılıç Ali Paşa Mosque underwent restoration in 2010. During this work, a fire broke out around 3:20 PM, originating from wooden scaffolding and spreading due to flammable materials. Though the exact cause remains uncertain, it is suspected to have been an accident or an electrical fault. The fire was extinguished in approximately 30 minutes, with no casualties, but it caused significant panic among the public (URL 2), (Figure 2).

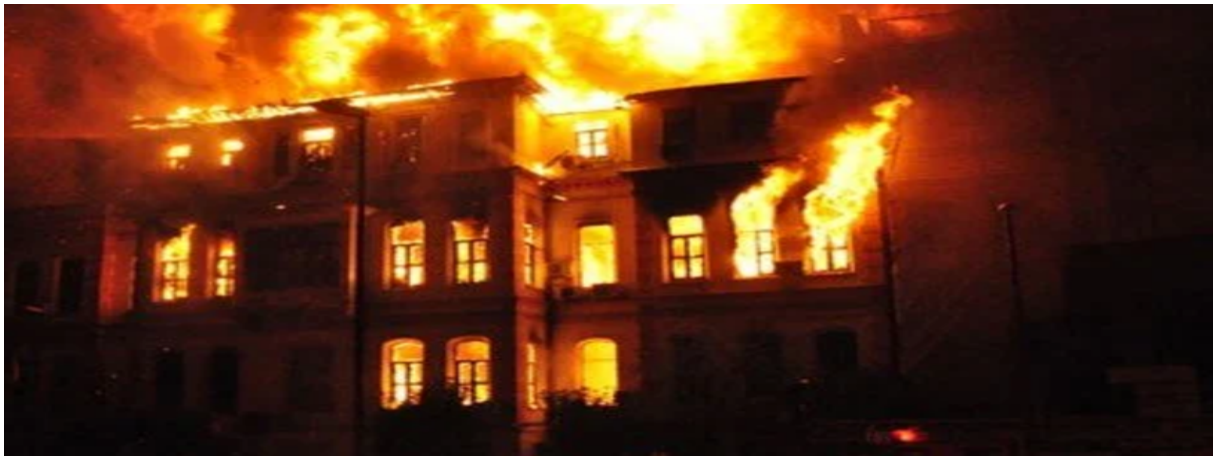
Figure 4. Provincial Directorate of National Education Fire (URL 5)

Constructed in the late 1800s, this building served as the Ministry of Education during both the Ottoman and Republican eras (Pehlivan, 2017). A fire broke out early in the morning in Block A, when the building was unoccupied. Due to the wooden structure, the flames spread quickly, rendering the building unusable. The ashes reportedly spread across a 200-square-meter area. The cause of the fire was determined to be an electrical fault (URL 1), (Figure 4).

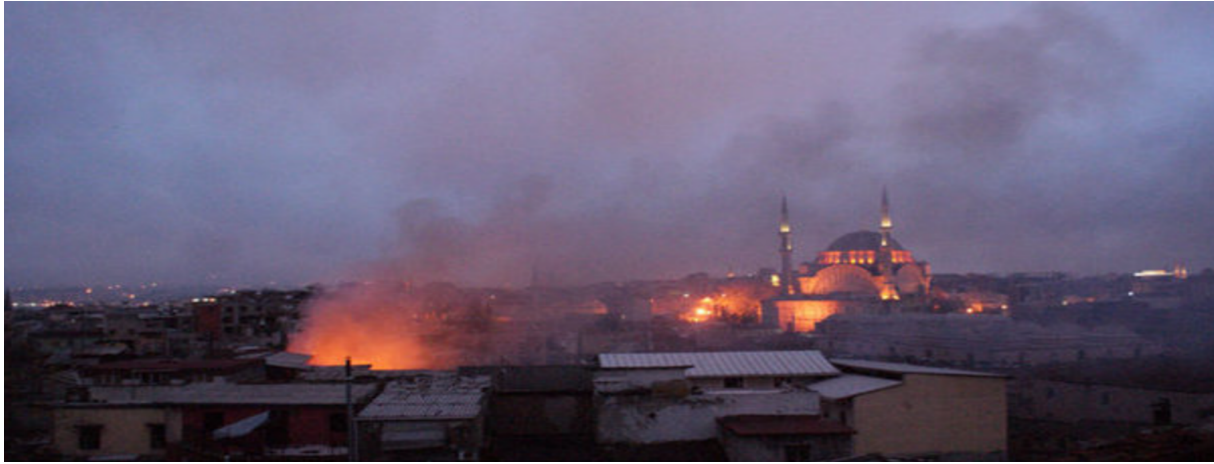
Figure 5. Grand Bazaar Fire (URL 9)

One of Istanbul's most iconic sites, the Grand Bazaar (Kapalıçarşı), originally known as the "Great Market" (Büyük Çarşı), was built in 1462 by Sultan Mehmed the Conqueror (Akozan, 1979). Spanning 30,700 square meters, it contains 4,000 shops, 5 mosques, 10 wells, and other features (Atılgan, 2013). A fire broke out at the Örucüler Gate security booth, caused by an electrical fault. Despite efforts, the dense structure of the market made firefighting challenging (Pehlivan, 2017), (Figure 5).

- **Rapid Spread:** The interconnected wooden elements and aged materials in many historical sites allow fires to spread quickly, as seen in the Kapalıçarşı fire of 2012.
- **Structural Fragility:** Many buildings are fragile and unable to withstand the pressures exerted by modern firefighting methods, such as high-pressure water jets.
- **Inadequate Fire Safety Measures:** The lack of built-in fire detection and suppression systems in most historical structures results in delayed response times, exacerbating damage (Çapan, 2019).

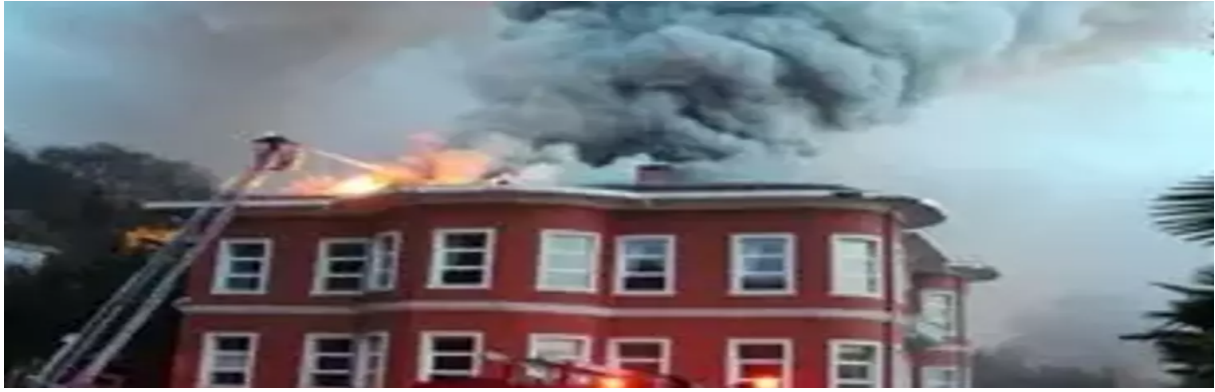
Figure 7. Müşir Fuat Paşa Mansion Fire (Yalçın, 2013)

Located in Istanbul's İstinye district, this 19th-century mansion served various purposes over the years. On April 10, 2013, a fire broke out on the roof early in the morning. Flames spread rapidly, requiring support from multiple fire brigades across Istanbul. The fire, fueled by the mansion's wooden structure, was extinguished after an hour of effort by 85 firefighters and 120 vehicles. The fire was linked to an electrical panel malfunction (Yalçın, 2013), (Figure 7).

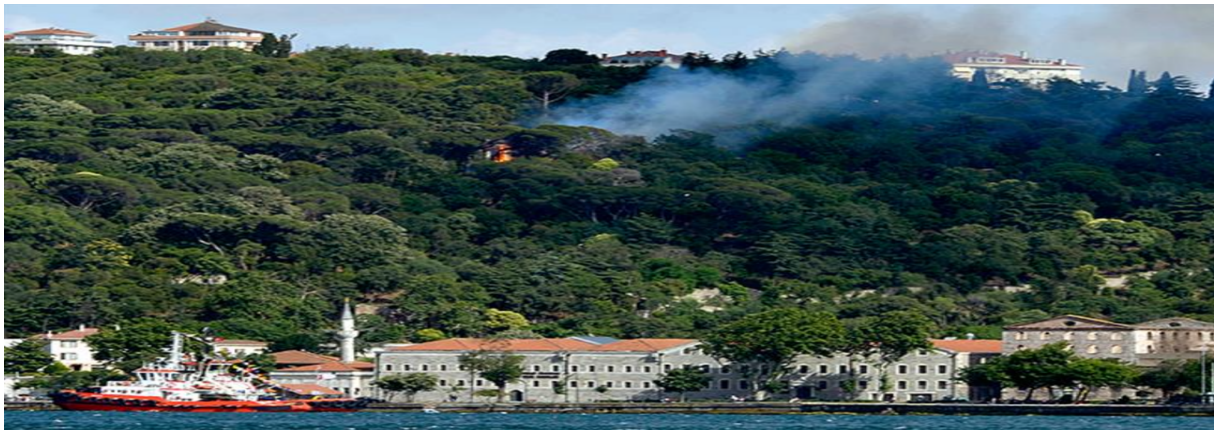
Figure 8. Hüseyin Avni Paşa Mansion (URL 4)

Located within the Hüseyin Avni Paşa Grove, this historic mansion caught fire for reasons that remain undetermined. Fire brigades from Çengelköy, Üsküdar, and Kadıköy, supported by aerial units, managed to prevent the fire from spreading further. However, the mansion was severely damaged and became unusable (URL 4), (Figure 8).

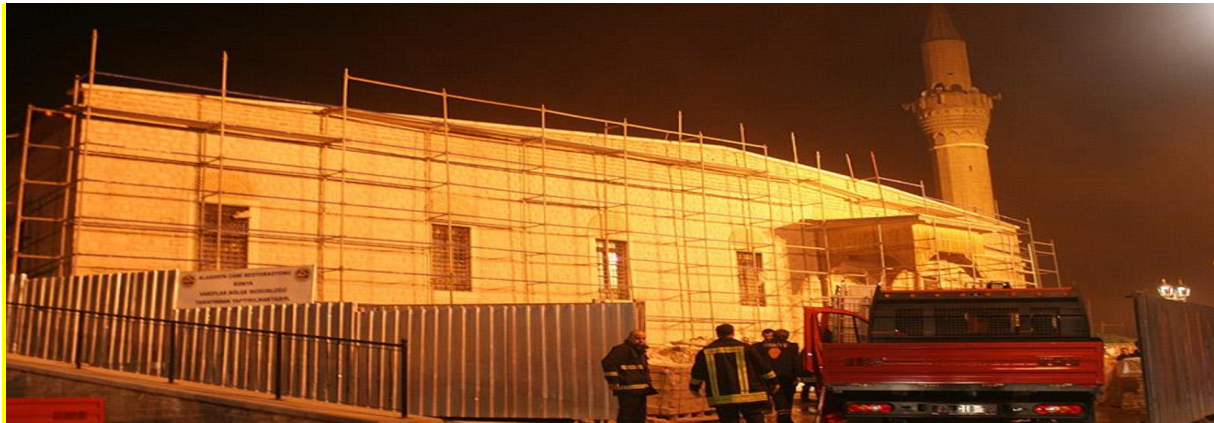
Figure 9. Alaaddin Mosque Fire (URL 8)

As one of Konya's oldest Seljuk-era structures, the Alâaddin Mosque suffered a fire when restoration work using a heat gun caused the wooden ceiling and paint to ignite. The fire was quickly brought under control, but the ceiling and beams sustained significant damage (Pehlivan, 2017), (Figure 9).

significantly increase the fire spread rate. The 2015 Alâaddin Cami fire in Konya occurred when flammable paints on wooden ceilings ignited during restoration work, causing extensive damage to the structure's interior (Pehlivan, 2017).

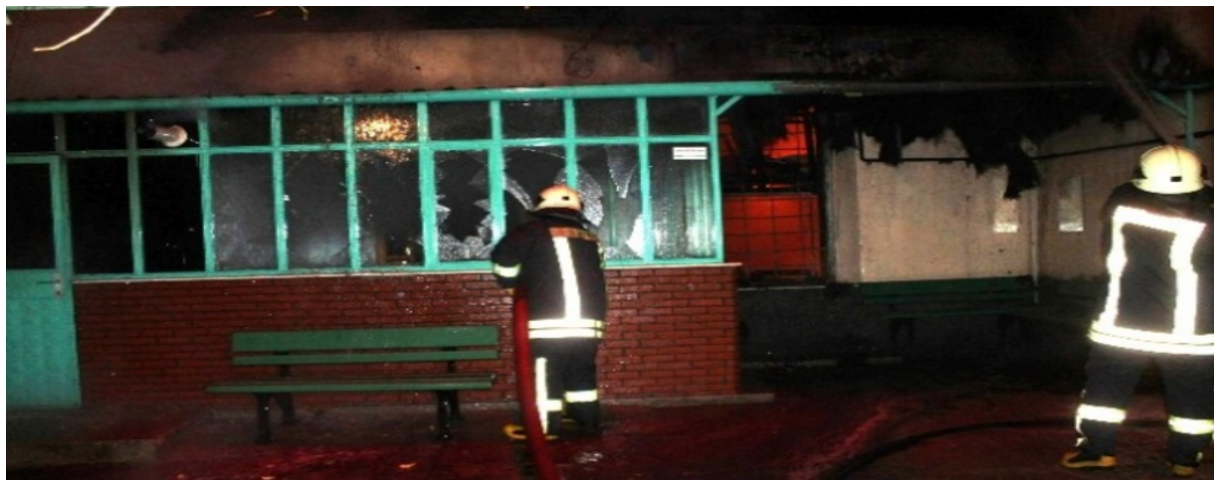
Figure 10. Fahrünnisa Mosque Fire (URL 6)

Located in Konya's Meram district, the 100-year-old Fahrünnisa Mosque caught fire due to a short circuit in the underfloor heating cables. Despite extensive firefighting efforts, the mosque suffered irreparable damage and was rendered completely unusable (Pehlivan, 2017), (Figure 10).

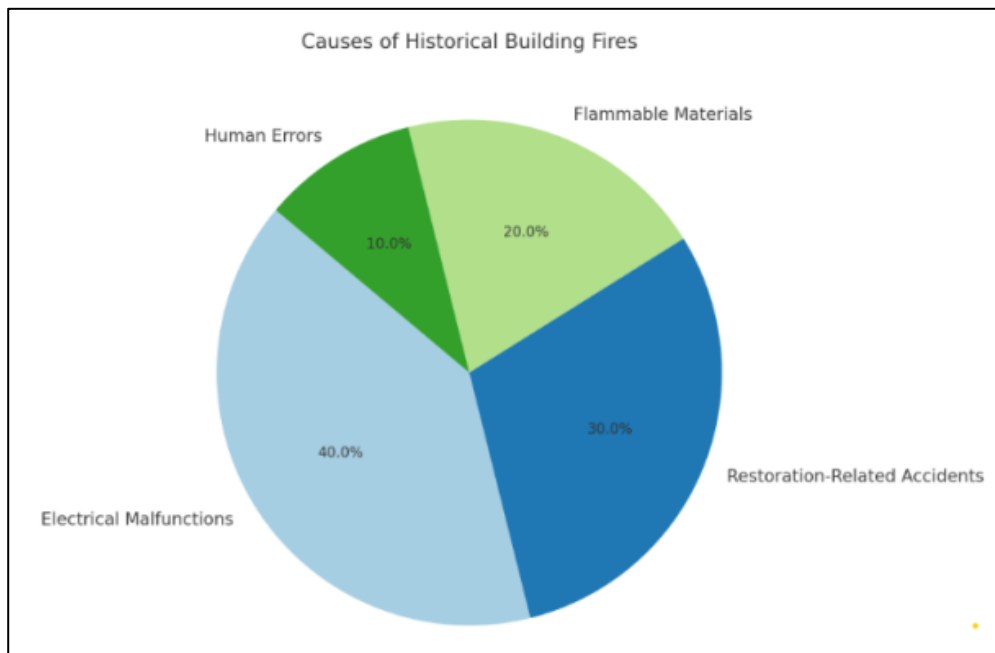
Figure 11. Causes of historical building fires

Electrical malfunctions represent the largest proportion of fire causes. Historical buildings often feature outdated or poorly maintained electrical systems that cannot meet modern energy demands. Such systems are prone to short circuits and overheating, as seen in the Galatasaray University fire in 2013, which originated from overheated electrical cables. Upgrading electrical systems with minimal structural interference is critical to mitigating this risk. Restoration-related activities are the second most significant cause, accounting for 30% of fire incidents. The use of heat-emitting tools, inadequate fire safety protocols, and accidental ignition of flammable substances during restoration projects pose significant risks. For example, the Alâaddin Mosque fire in 2015 resulted from a heat gun igniting flammable materials. This highlights the paradoxical risk where efforts to preserve structures inadvertently contribute to their destruction. Flammable materials, such as wood and flammable paints, are a defining feature of many historical buildings. These materials exacerbate fire spread and make extinguishment challenging. Fires like the one in the Grand Bazaar in 2012 underline the need for fire-resistant treatments and improved suppression systems. Human errors, often linked to negligence or mishandling of equipment, represent 10% of fire causes. Incidents such as the Kılıç Ali Paşa Mosque fire in 2011 emphasize the importance of strict safety protocols and proper training for personnel involved in restoration or maintenance. Studies emphasize the need for a multi-faceted approach to fire risk management in historical buildings. Regular risk assessments, integration of non-invasive fire safety systems, and comprehensive training programs are vital. Moreover, collaboration between preservation authorities and fire safety experts can enhance both preventive measures and response strategies, balancing safety with the need to maintain architectural integrity (Figure 11).

The distribution of fire causes underscores the importance of targeted interventions. Electrical upgrades, safer restoration practices, fireproofing of materials, and rigorous personnel training are essential to safeguarding cultural heritage. This holistic approach ensures not only the structural preservation of historical buildings but also the continuity of the cultural identity they embody.

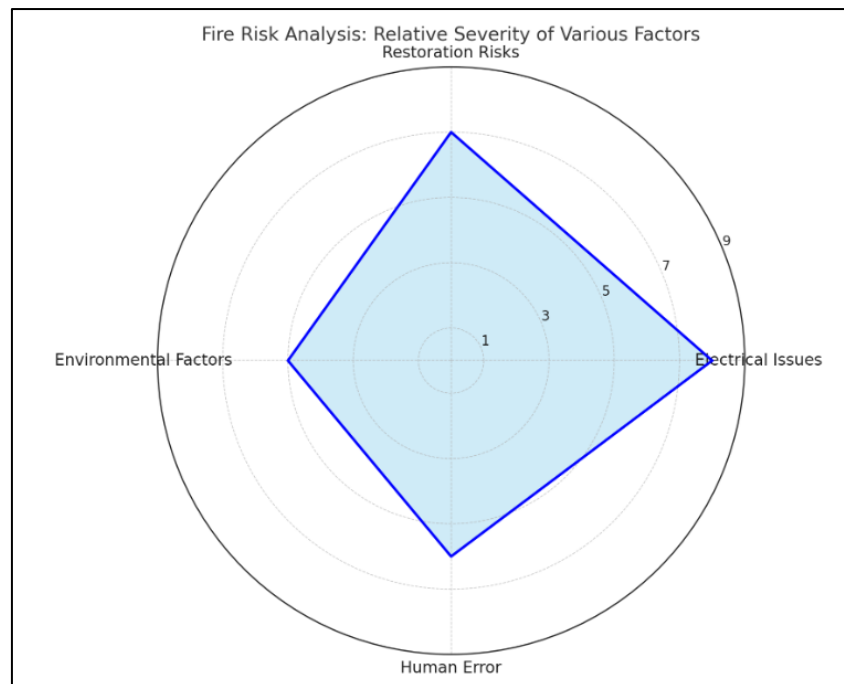
Figure 12. Relative severity of various factors restoration risks

Figure 12 provides a comparative visualization of the relative severity of various fire risks in historical buildings. The axes represent key risk factors: Electrical Issues, Restoration Risks, Environmental Factors, and Human Error, each evaluated on a severity scale from 1 to 10. The insights from this chart are derived from both historical patterns and expert analysis on fire incidents.

Electrical Issues (Severity: 8), Electrical issues rank as the most severe risk, highlighting their pervasive impact on historical building fires. Aging infrastructure and insufficient maintenance often lead to short circuits or overheating. This is consistent with documented incidents like the Grand Bazaar fire in Istanbul, where outdated electrical systems exacerbated the fire risk.

Restoration Risks (Severity: 7), Restoration activities pose significant risks due to the use of heat-emitting tools and flammable materials. Despite their intention to preserve heritage, these activities can lead to unintended disasters, as seen in the Alâaddin Mosque fire caused by heat guns igniting wooden beams.

Environmental Factors (Severity: 5), Environmental risks, including lightning strikes or accidental external fires, have a moderate severity. While less common than other causes, these risks are more challenging to predict and manage, necessitating advanced preventive measures such as fire-resistant treatments.

Human Error (Severity: 6), Human error, though ranked lower than electrical or restoration risks, remains a significant contributor. Negligence during maintenance or mishandling of tools can lead to accidents, as observed in the Kılıç Ali Paşa Mosque fire.

The chart underscores the need for a comprehensive risk management strategy:

Electrical Systems: Regular inspections and upgrades with non-invasive technology to reduce risks without altering the architectural integrity.

Restoration Protocols: Training for restoration teams on fire safety practices and the use of non-flammable materials and tools.

Environmental Safeguards: Installing lightning rods and fire-resistant coatings to mitigate external risks.

Human Error Reduction: Strengthening safety protocols and conducting periodic fire drills to ensure preparedness.

This spider chart serves as a valuable tool for prioritizing interventions and resource allocation. By focusing on high-severity risks such as electrical and restoration issues, authorities can significantly reduce fire incidents in historical buildings while preserving their cultural significance.
