DETERMINATION OF DAMAGE AMOUNT AND AGRICULTURAL INSURANCE SUPPORT STATUS OF GREENHOUSES DAMAGED BY NATURAL DISASTERS IN ANTALYA

Araştırma Makalesi/Research Article
DOI: 10.38065/euroasiaorg.275

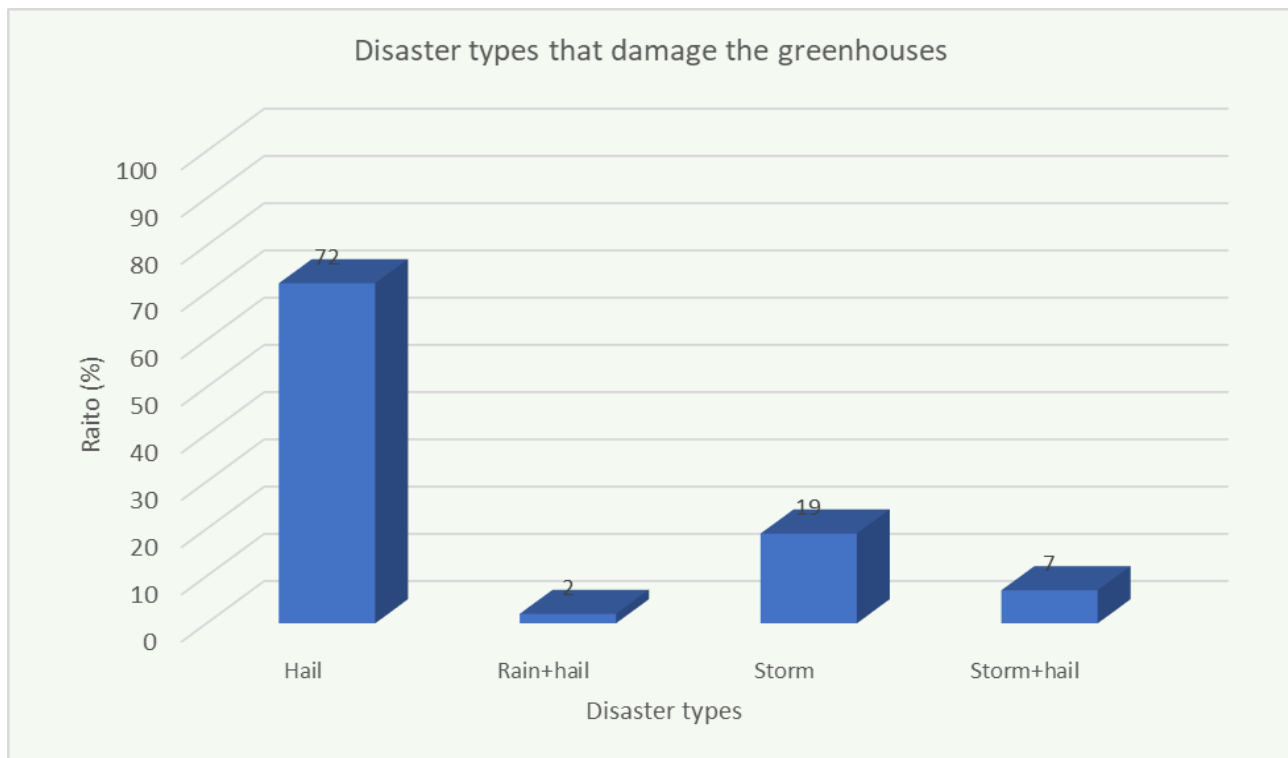
Figure 4. Disaster types that damage the greenhouses

Disaster types that damage businesses were shown in Figure 4. As can be seen from the figure, 72% of the enterprises damaged by hail, 1% by rain and hail, 19% by the hurricane, 1% by heavy rain and hail, 7% by hail and hurricane. As many as 91% of the greenhouses damaged hail and from storms or hurricanes. It was determined that 100% of the greenhouses damaged by the disasters were built by blacksmiths. Those greenhouses have no static plan and project and build with insufficient thickness profiles. For this reason, more likely to be damaged in natural disasters. Greenhouse construction profiles should be selected by calculating the fixed and moving loads affecting the greenhouse building elements and performing static analyzes in terms of bending, vertical displacement and flambage. Standard galvanized steel profiles or aluminum box profiles should be used in the selection of the elements forming the column and roof truss as the skeleton material in the greenhouse construction (von Elsner vd. 2000; Critten ve Bailey 2002; Yüksel 2004; Havgören ve Kürklü 2007; Baytorun 2016; Büyüktaş vd. 2016).
